View: Port side, Amidships. Looking at Grunion Sail

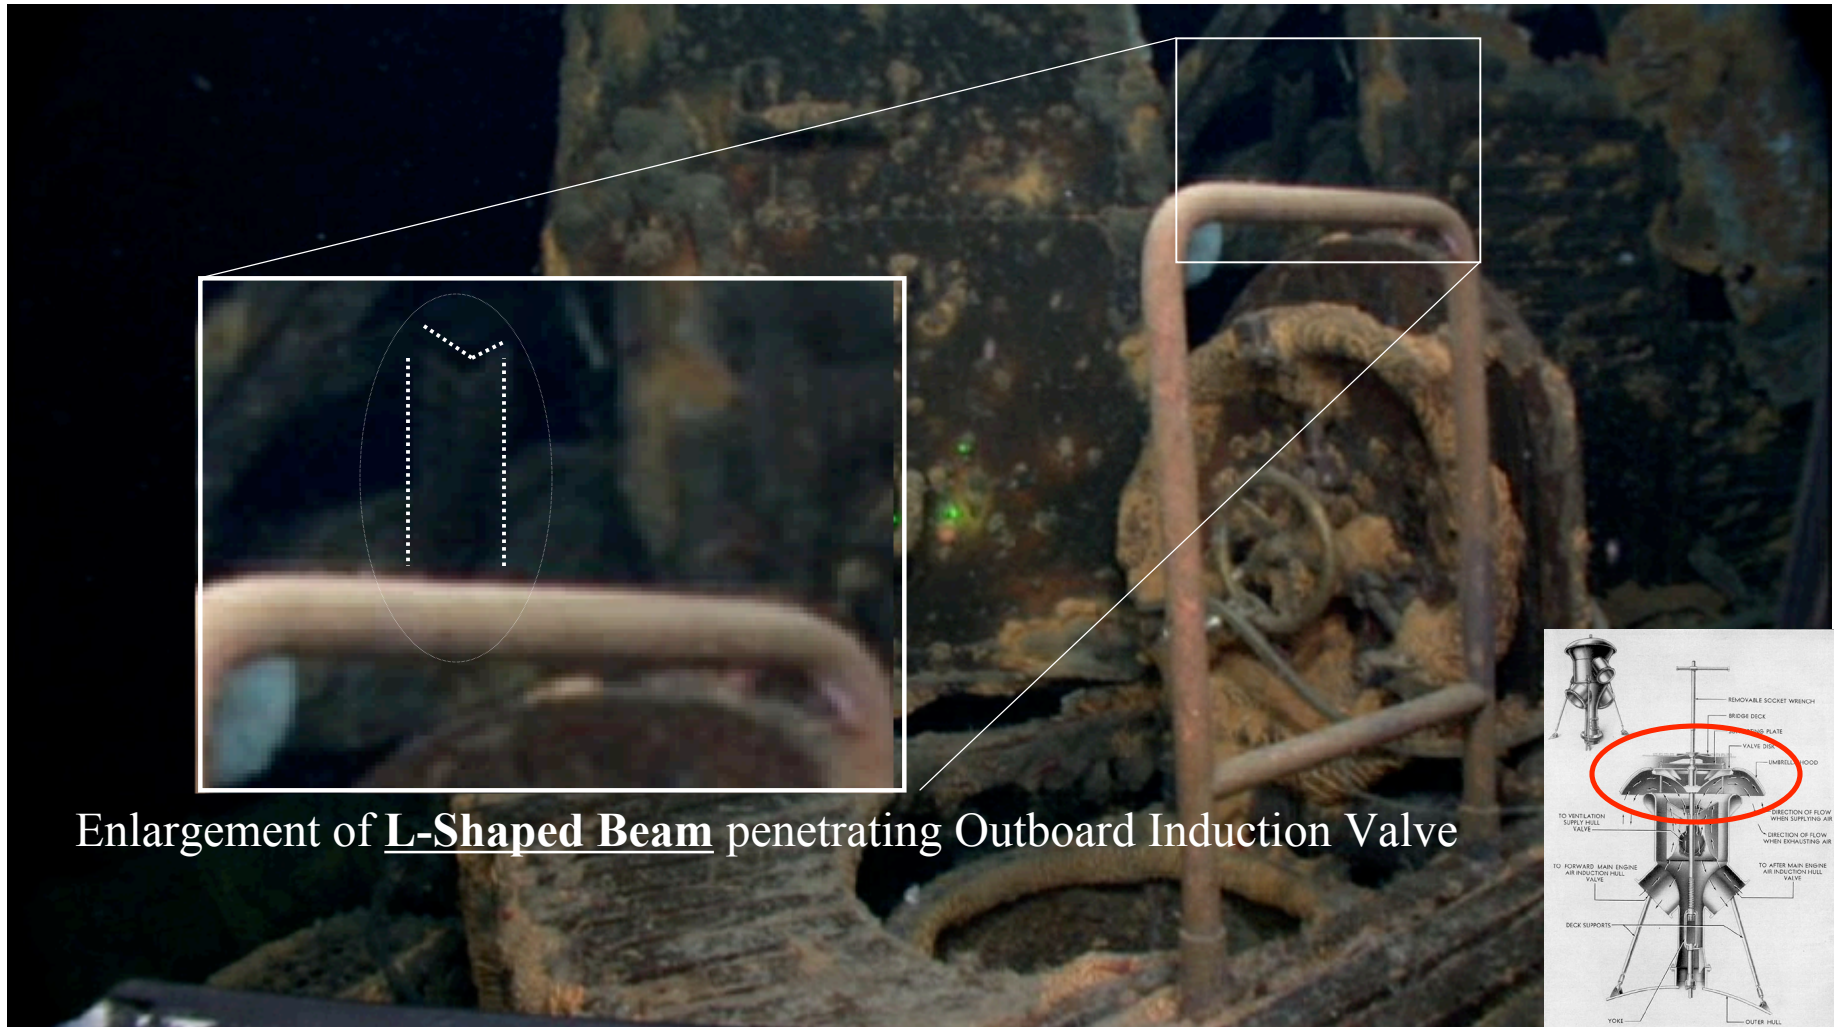
Enlargement of L-Shaped Beam penetrating Outboard Induction Valve

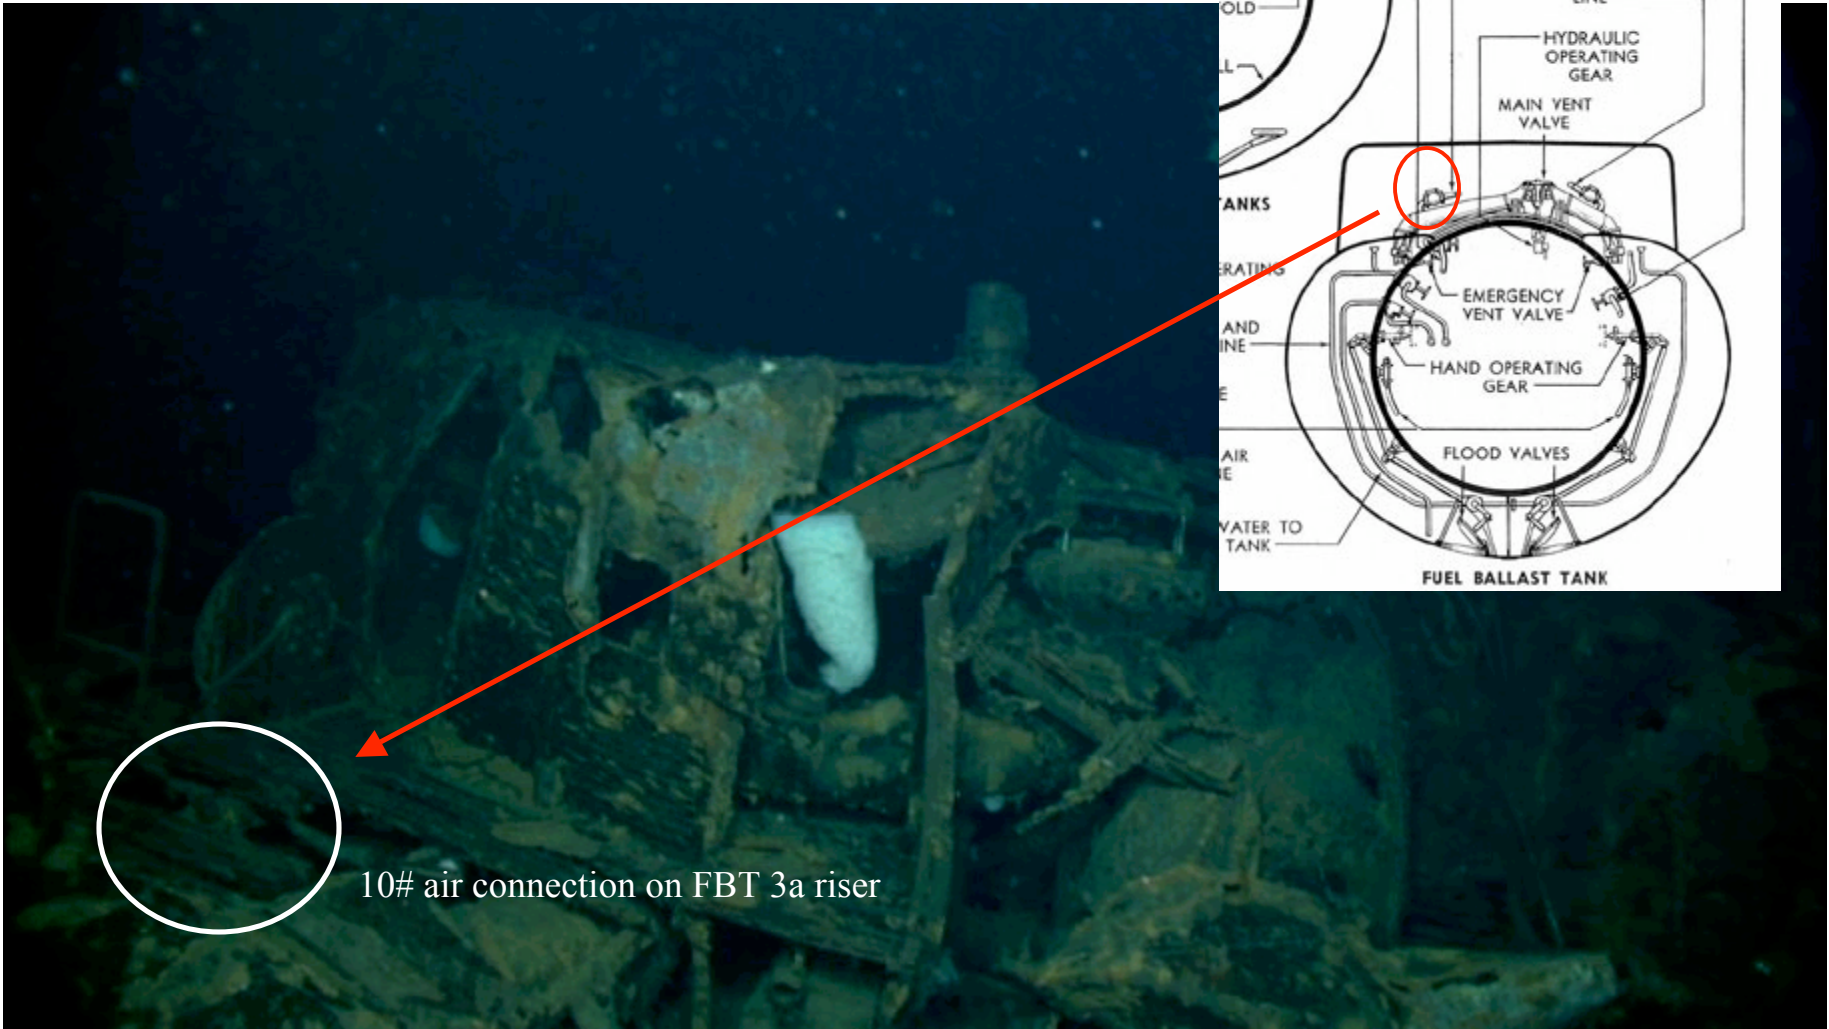
10# air connection on FBT 3a riser

Possible Fuel Ballast Tank 3 Vent Riser and 10# air connection
source: attack analysis 2: Open hatch 22

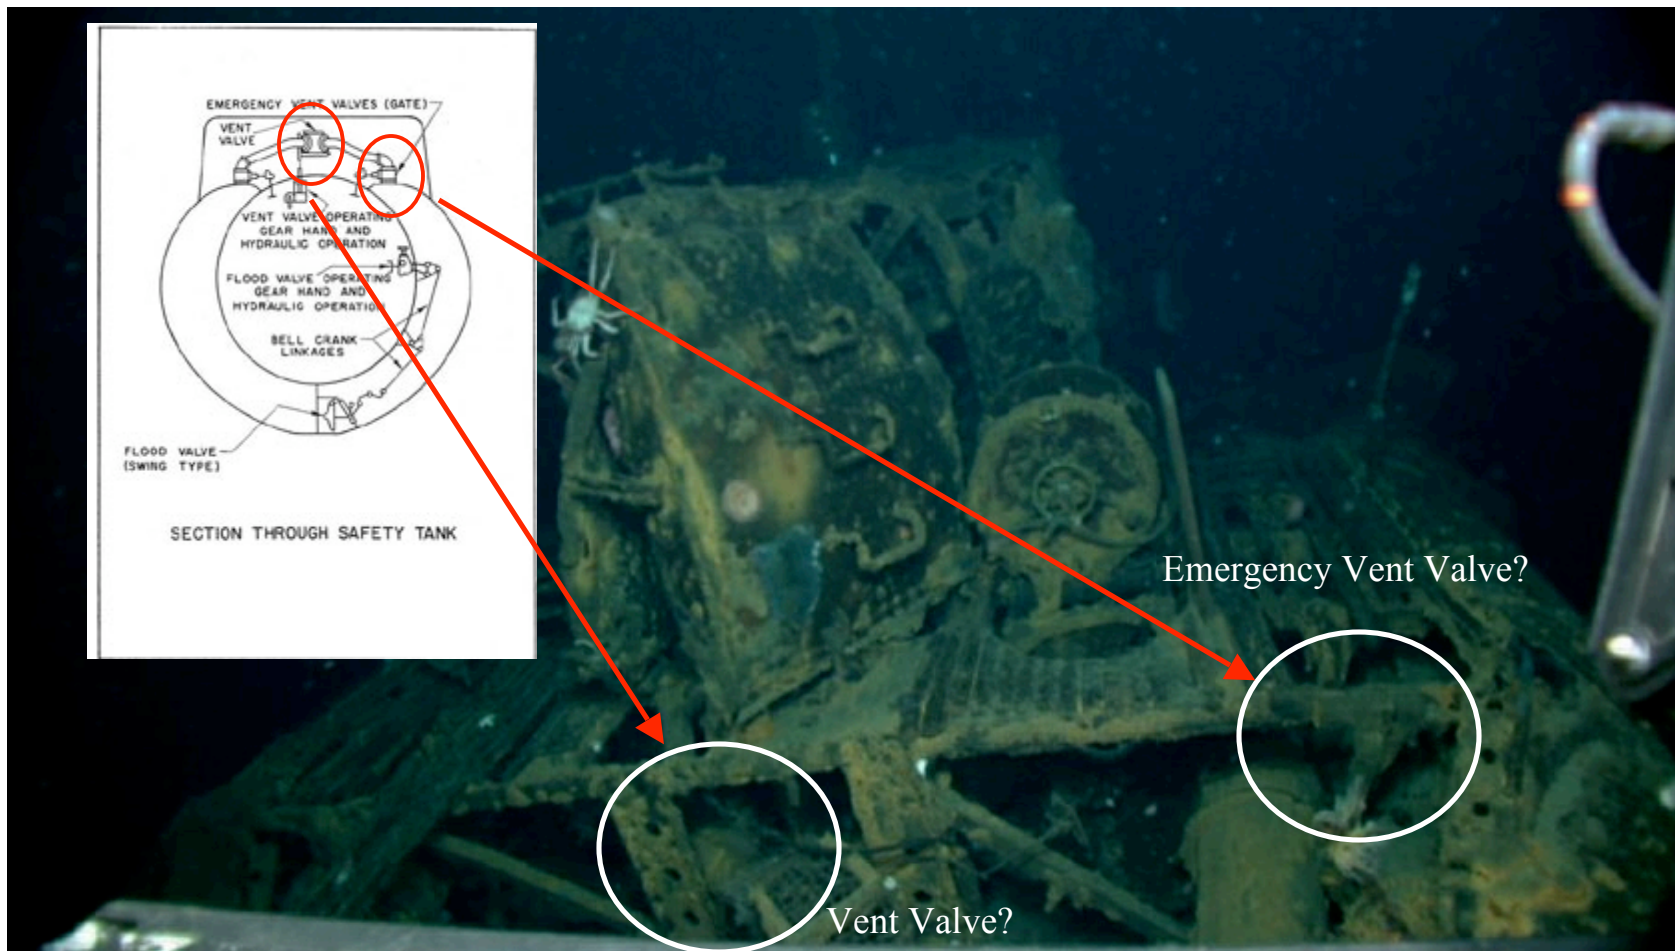
Possible **Safety Tank** Vent Riser, Vent, and Emergency Vent Valves.

Is there damage?

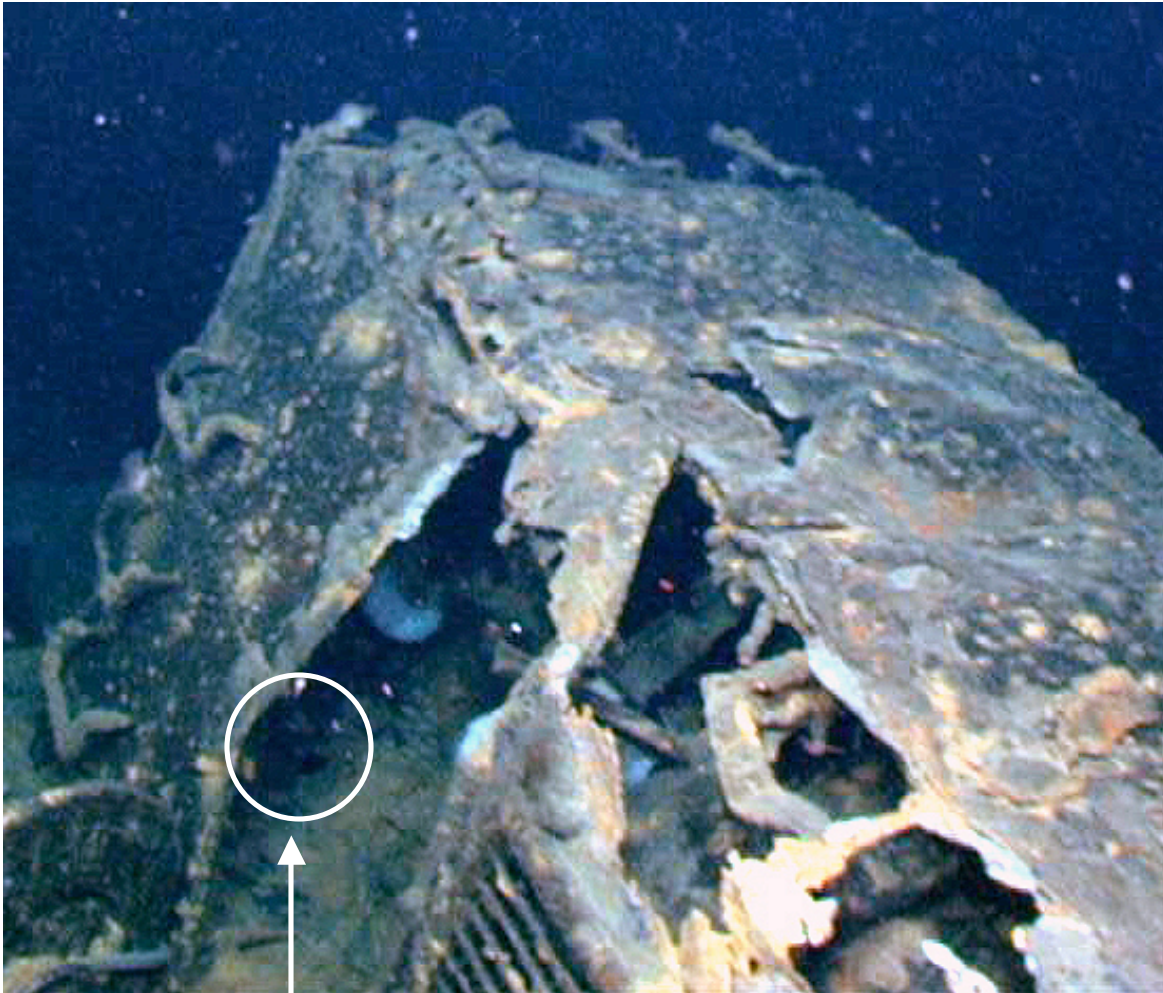
Possible shell damage / hole in deck in aft Conning Tower Fairwater
