View: Port side, Amidships. Looking at Grunion Sail

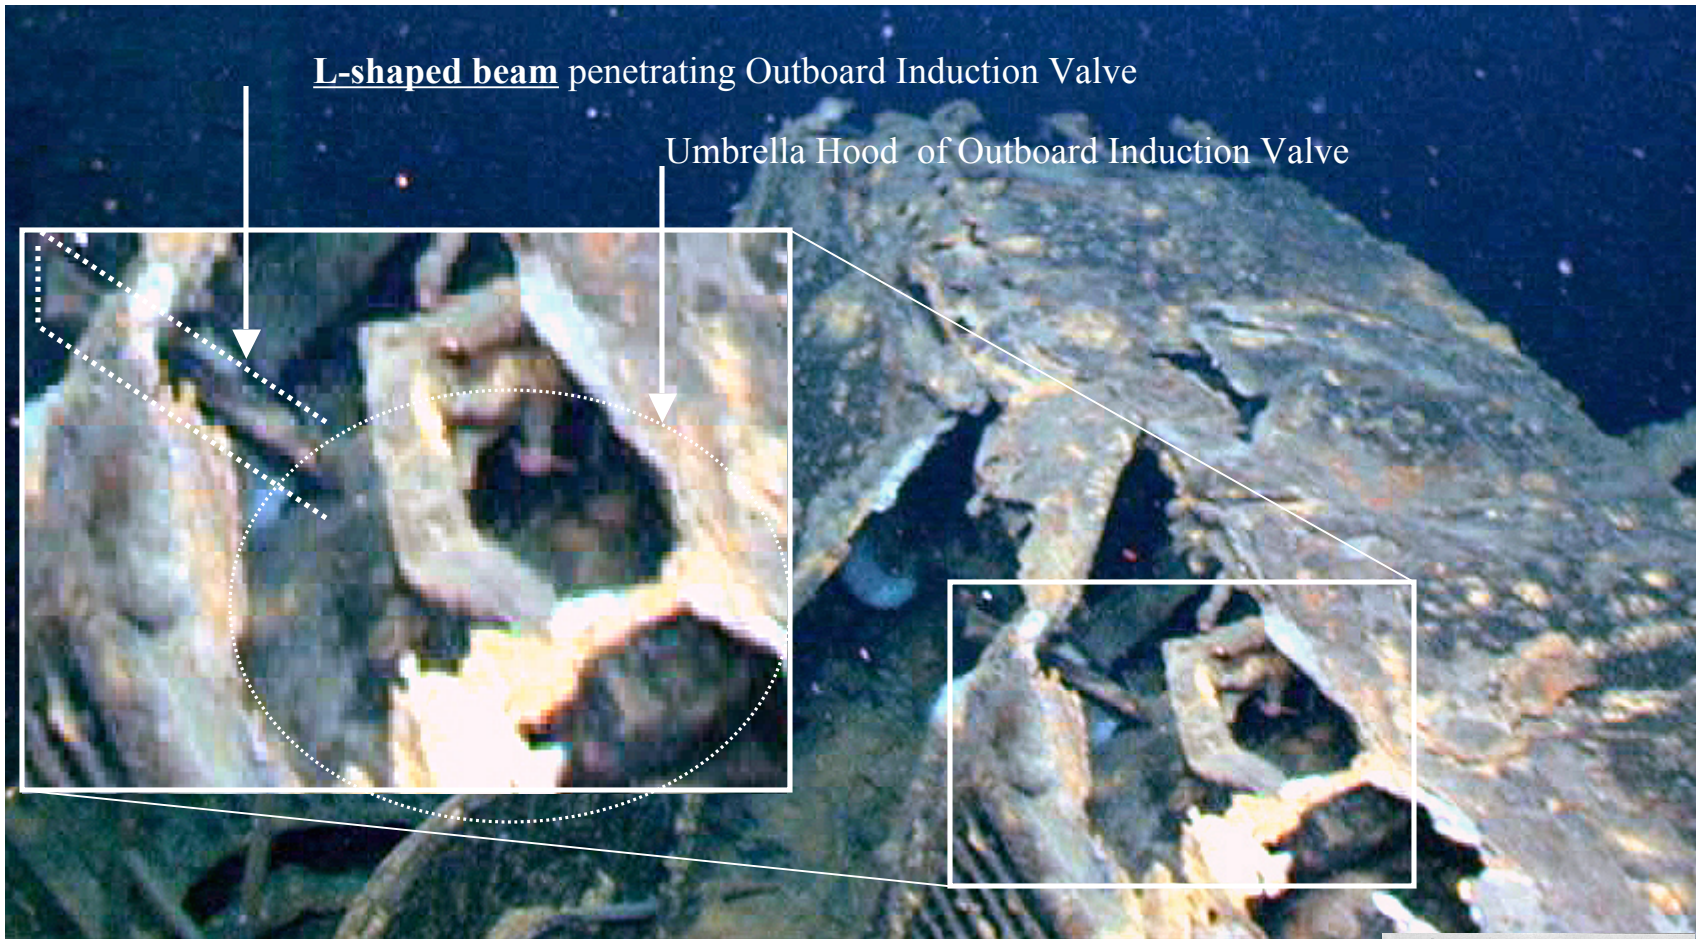
Amidships; starboard side, looking to port; Camera is outboard of open After Battery Hatch source: Attack Analysis 2, open hatch 16, photo#5115765628423339762
