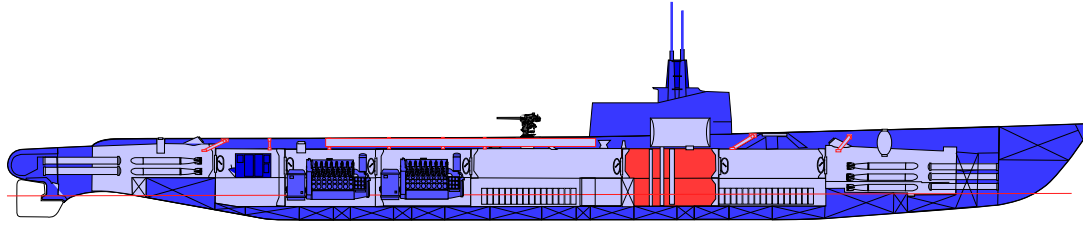
For some reason, possibly a shell hit, the control room is rendered inoperative. The boat starts to sink with a bow down attitude.

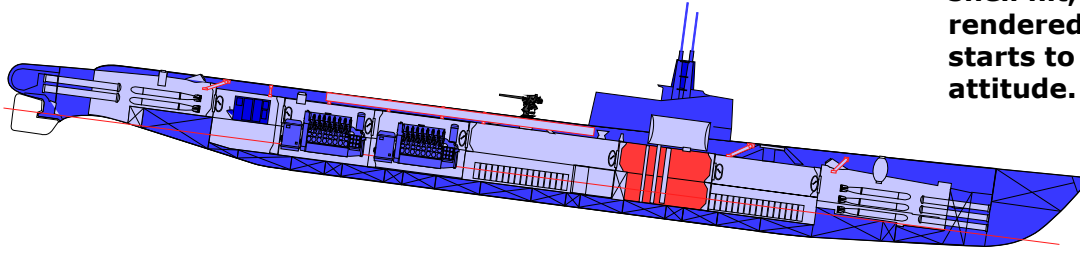
The boat slowly takes more of a down angle

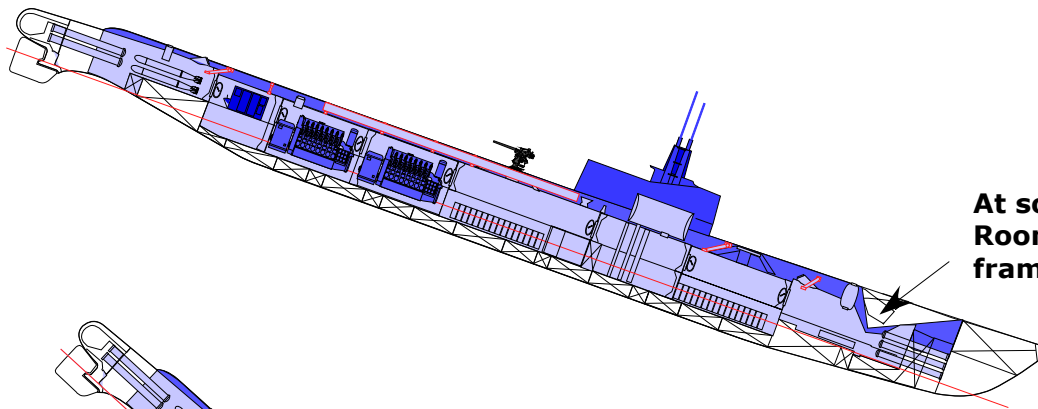
At some depth, the Torpedo Room structure fails between frames 17 and 27

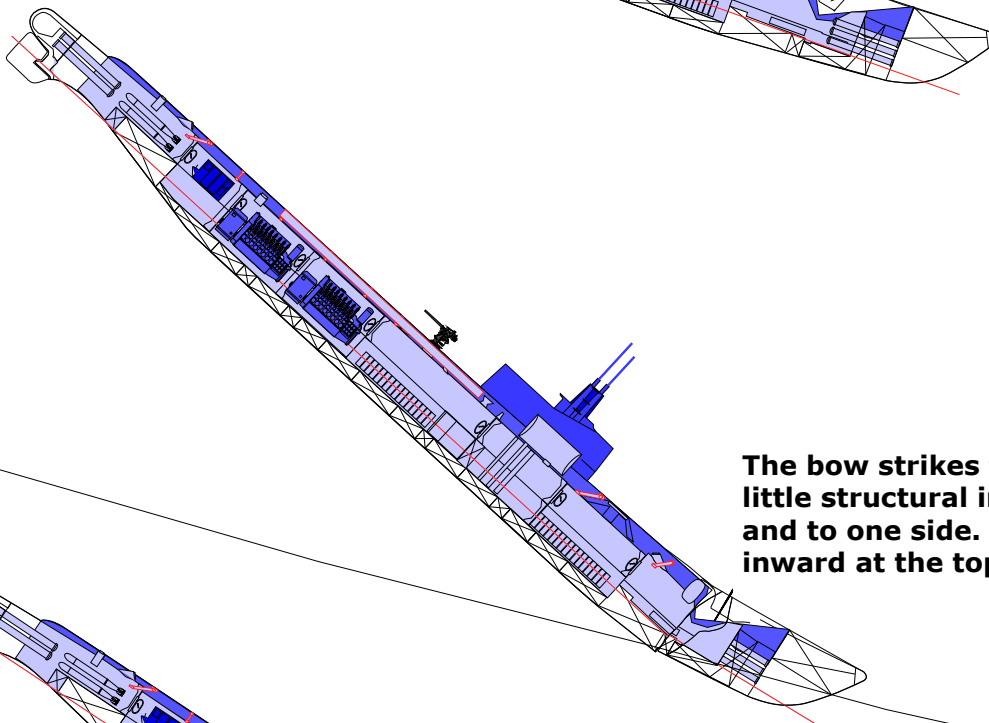
The bow strikes the bottom and with little structural integrity it bends upward and to one side. Bending the hull structure inward at the top and tearing it near the keel

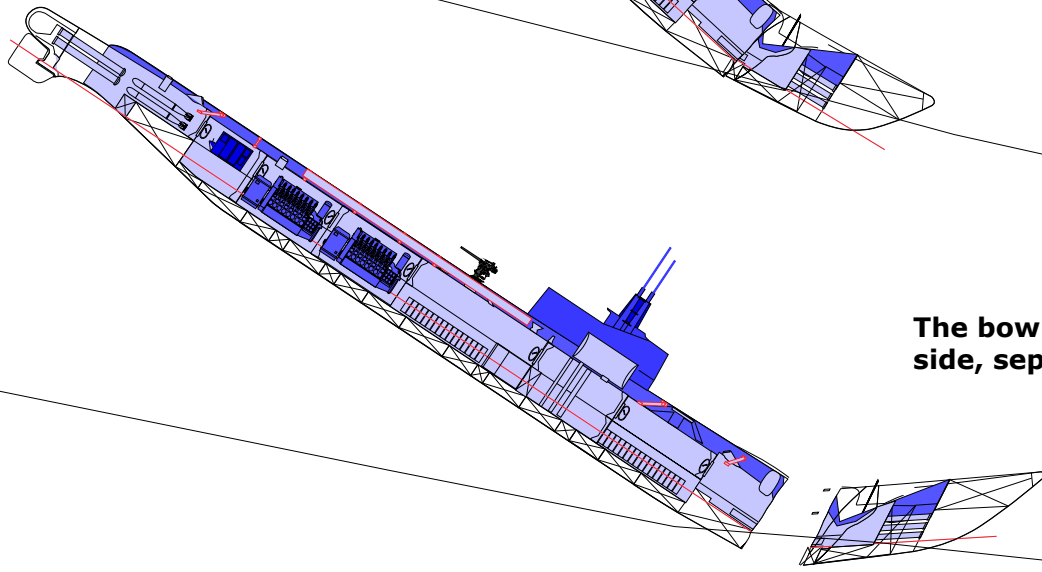
The bow tears off upward and to one side, separating from the hull.

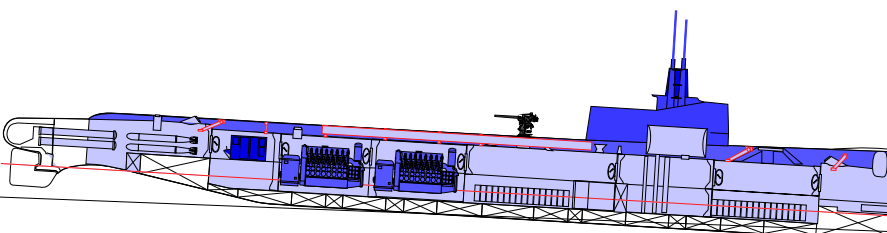
What we see now, it the open end of the Torpedo room looking aft from the vicinity of Frame 27
